Lower Blackwood Catchment
Land Conservation District Committee

Case Study

Evaluation of Landcare Riparian

Restoration Projects in the Scott River

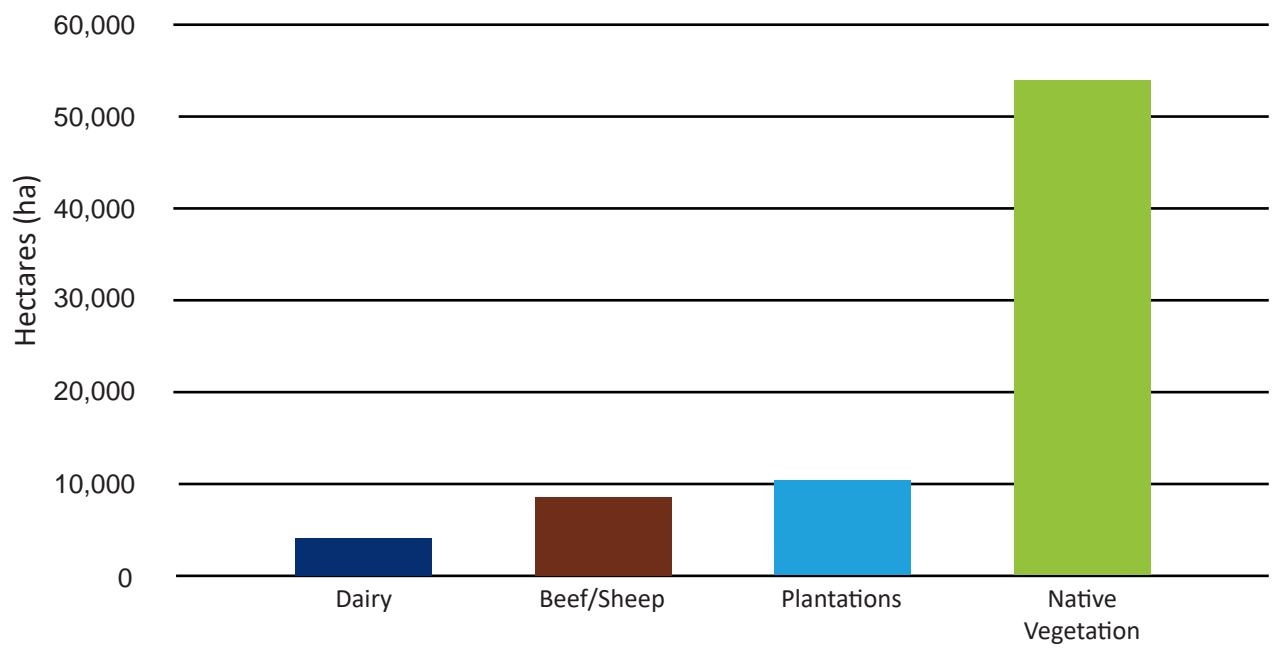
Figure 3: Summary of Land Use in the Scott Catchment (ha)
